Case Study - Petroleum Production Scale in the Recycled Water Line

Customer: Natural gas and oil producer in Nikiski, Alaska, USA.

Application: Offshore petroleum production operation. The device was installed on a 4.5" outer diameter recycled water pipe, after the separator.

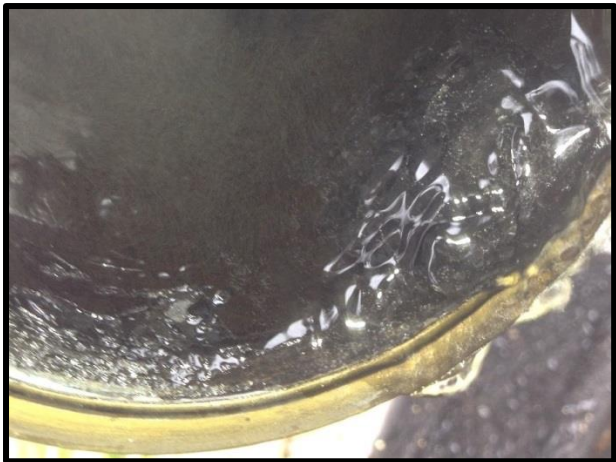
Installation - October 17, 2013

Baseline - Hard scale of roughly 1/2" along the inside of the pipe. The scale is dark because it is a mix of iron (predominantly), magnesium, calcium carbonate, silicon and other minerals.

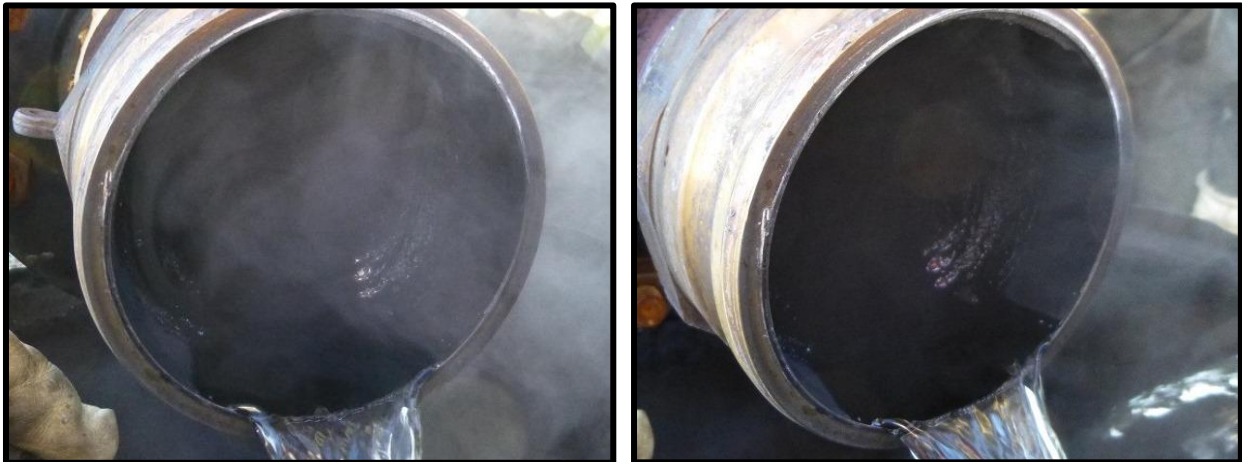
Second inspection - November 18, 2013

One month after the *HydroFLOW* 120i was installed - Apart for what seems like a thin magnetite layer, hard scale is not accumulating on the area that was cleaned after the first inspection. Existing scale can be flaked off with a finger and is roughly 1/8" to 1/4" thick. The customer's personnel were very surprised because typically removal of scale involves hard manual labor.
