Commercial cooling Tower Case Study - 90 Day Evaluation

Installer: HydroFLOW Master Distributor in Hawaii.
Customer: Central Pacific Plaza
Location: Honolulu, Hawai - USA
Application: Two 300 ton cells and one 75 ton cell - One 300 ton cell operates during the day, one 300 ton cell is on standby and the 75 ton cells operates during the night
Unit: HydroFLOW 14" Custom on a 12.78" Outer Diameter Cast Iron Pipe
Goal: Keep biological growth, scale accumulation and corrosion rate under control while using minimal amounts of chemicals
Timeframe: Trial began on January 22, 2013 and ended on April 22, 2013

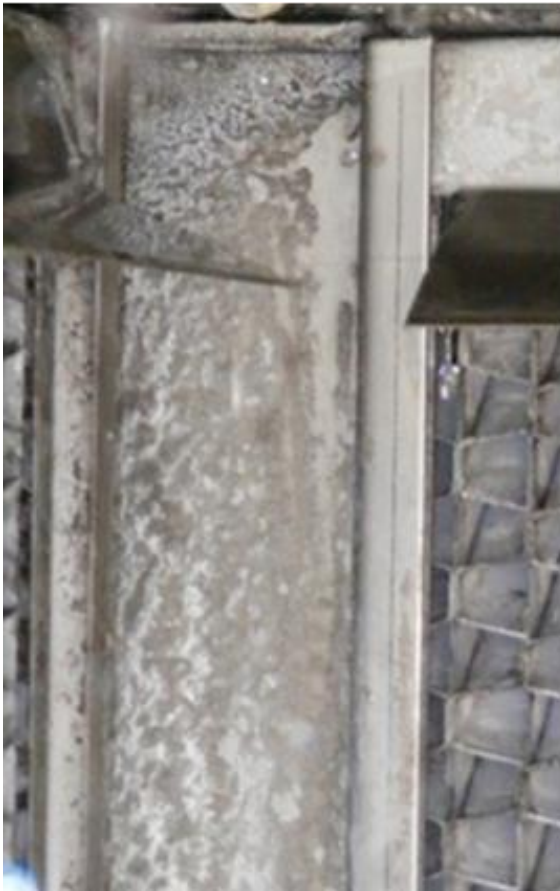
Before

Lime scale and corrosion buildup remained under control even though anti-scalant and anti-corrosive chemicals were discontinued

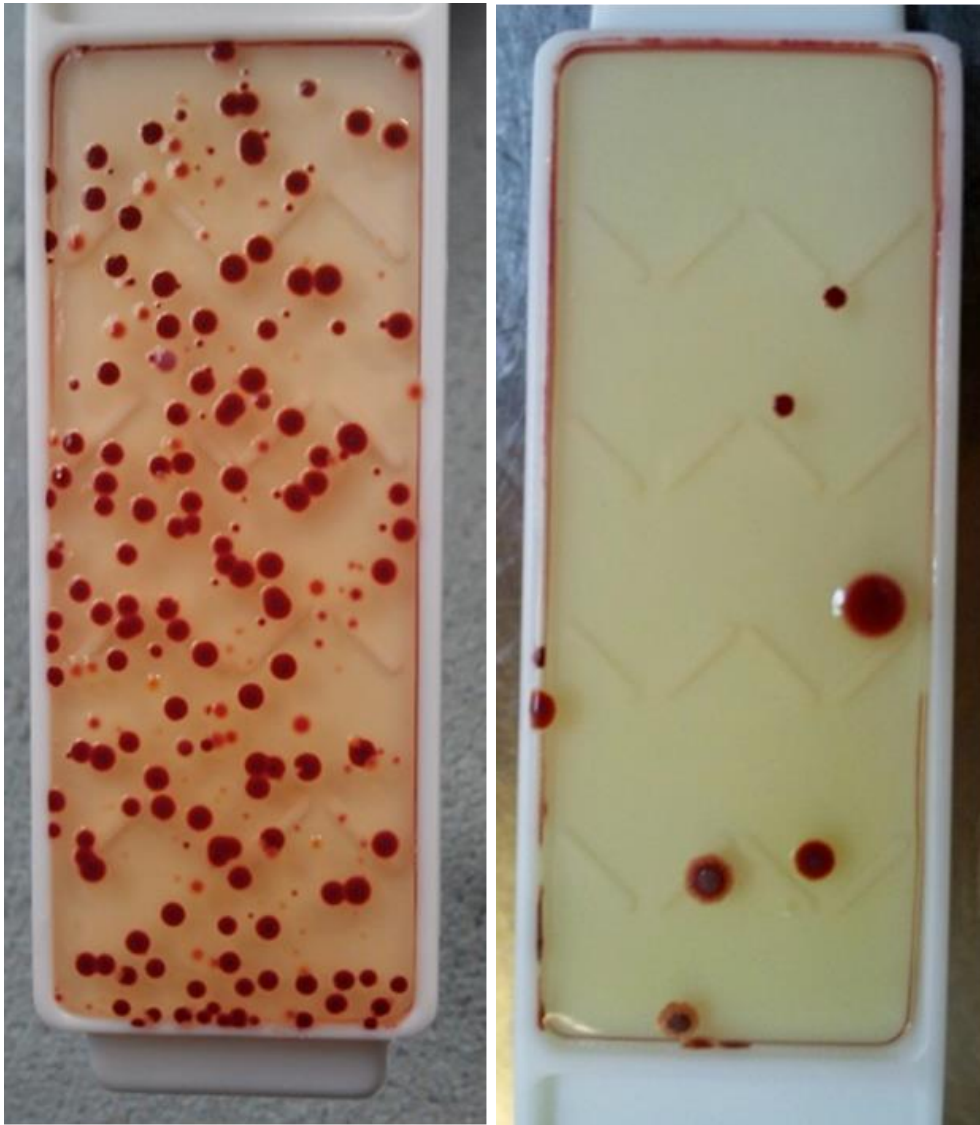
[Dip slides were used to monitor biological count]

Biocide chemical was reduced by 85% and bacteria levels reduced from 100,000 CFU to 1,000 CFU
