Third-Party Technology Verification of the Hydropath Technology at the Robert W. Hite Treatment Facility, Denver, Colorado

PREPARED FOR: Tal Journo
PREPARED BY: Samuel Jeyanayagam, PhD, PE, WEF Fellow/CH2M HILL, Inc. (CH2M)
DATE: 27 September 2017

This technical memorandum specifically discusses the verification testing completed at the Robert W. Hite Treatment Facility (RWHTF) in Denver, Colorado, and the observed outcome.

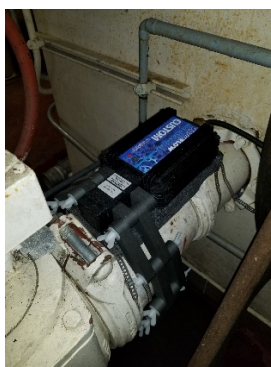
Figure 1. Typical *HydroFLOW* Unit Installation

The *HydroFLOW* I Range uses Hydropath technology. When properly installed on a pipe (see Figure 1), it induces a 150 kilohertz, oscillating sine wave, alternating current (AC) signal. The electric induction is performed by a special transducer connected to a ring of ferrites. The pipe and the flowing fluid act as a conduit, which allows the signal to propagate. The induced AC signal is believed to cause the mineral ions that make up struvite (magnesium, ammonium, and phosphate) to form loosely held together clusters. When certain conditions are created (e.g., pressure change, temperature change, and turbulence) the clusters precipitate out of solution and form stable crystals of struvite that remain in suspension and are not able to adhere to surfaces as hard scale; the crystals are carried away with the flow. Because hard scale no longer accumulates, the shear forces created by the flowing liquid erode and soften existing scale deposits over time. It is important to note that constant liquid flow is required to remove hard scale deposits from a system.

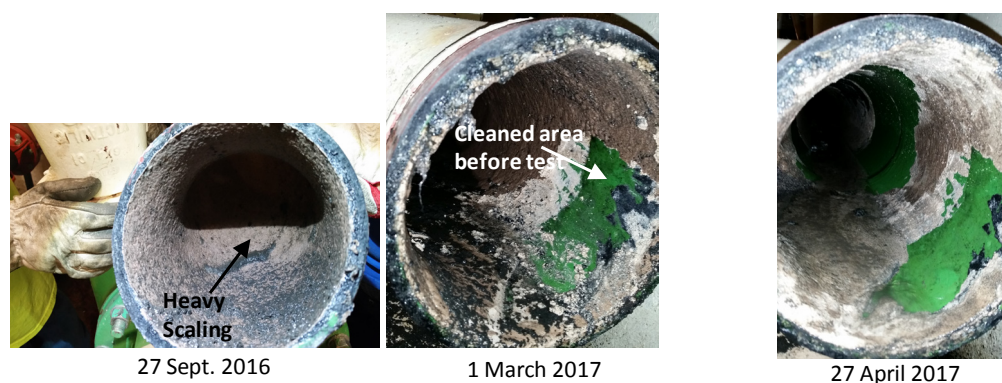
Figure 8. Before and After Photographs of the Transfer Pump Discharge Pipe

The before and after photographs of the pump discharge pipe between the transfer pump and second *HydroFLOW* unit are shown on Figure 8. The “before” photograph dated 27 Sept 2016 shows heavy scaling and reduced pipe inside diameter. The photograph dated 1 March 2017, before the test, shows the section of hard struvite that was cleaned to exposed the green, glass-lined pipe. The “after” photograph, dated 27 April 2017 shows the following:

- The clean section of the pipe remained clean, with no new struvite deposition.
- Some of the hard struvite had been gradually removed to further expose the pipe.
- The remaining struvite scale had become softer and thinner.

In general, RWHTF staff reported the following observations at the transfer pump and discharge pipe locations:

- Before the test, the scale was thick (approximately 1/8 inch), hard, and greyish in color. It was possible to collect large pieces of hard scale.
- Sixty days into the test, the scale was softer and thinner, with some areas of the surface becoming visible. The scale samples broke into smaller pieces.
- At the end of the test, the scale was significantly thinner, making it impossible to collect a scale sample. An increasing amount of surface was exposed.
