Document S

JORDAN RIVER HYDROELECTRIC POWER STATION

Country: Israel Distributor: Palbar

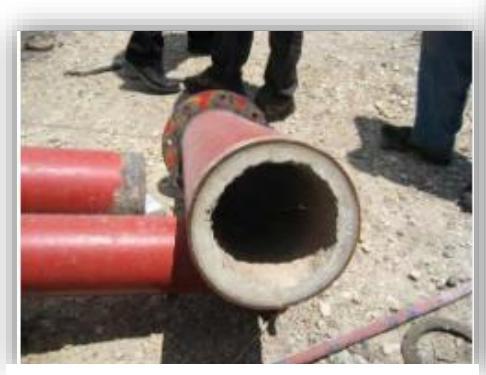
The pipeline to the power station was coated with a thick layer of extremely hard scale. Hydroflow prevented new scale from forming and began to remove existing scale.

The pipe is 3 to 4 kilometers long, and goes from a small lake to the Jordan River. The pipe sizes span from 16 inches to 30 inches. At the end of the pipeline there is a drop of 60m, at the bottom of which is a hydroelectric power plant. The problem was the build-up of limescale. There was a ring of very hard limescale 80mm thick all along the pipe. As the power is generated by the flow of water, clearly a layer of limescale this thick is a major problem.

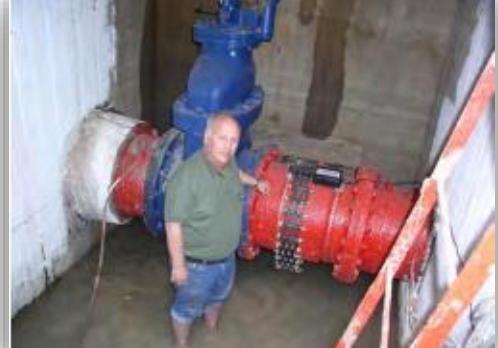
The water level in this area often rises above the level of the pipes

The plant is very happy with the success and with each new pipe installation, Hydroflow is also installed. The water level in this area often rises above the level of the pipes, and hence the units become completely submerged on occasion. As the conditioner units are completely waterproof (" IP68 rated"), this does not harm them. The Power Supply Units are installed above the high-water mark. While the signal will be reduced when the unit is under water, you can see that the units are not damaged and continue to work when the water level drops again.

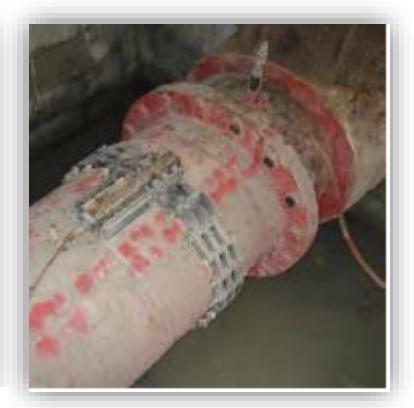
The same installation in 2010. No damage to the HydroFlow despite periods of submersion.
